National Transportation Safety Board Aviation Accident Preliminary Report

Location:	Elba, NY	Accident Number:	ERA22FA207
Date & Time:	April 26, 2022, 13:00 Local	Registration:	N507TJ
Aircraft:	BELL HELICOPTER TEXTRON CANADA 429	Injuries:	2 Fatal
Flight Conducted Under:	Part 91: General aviation - Instructional

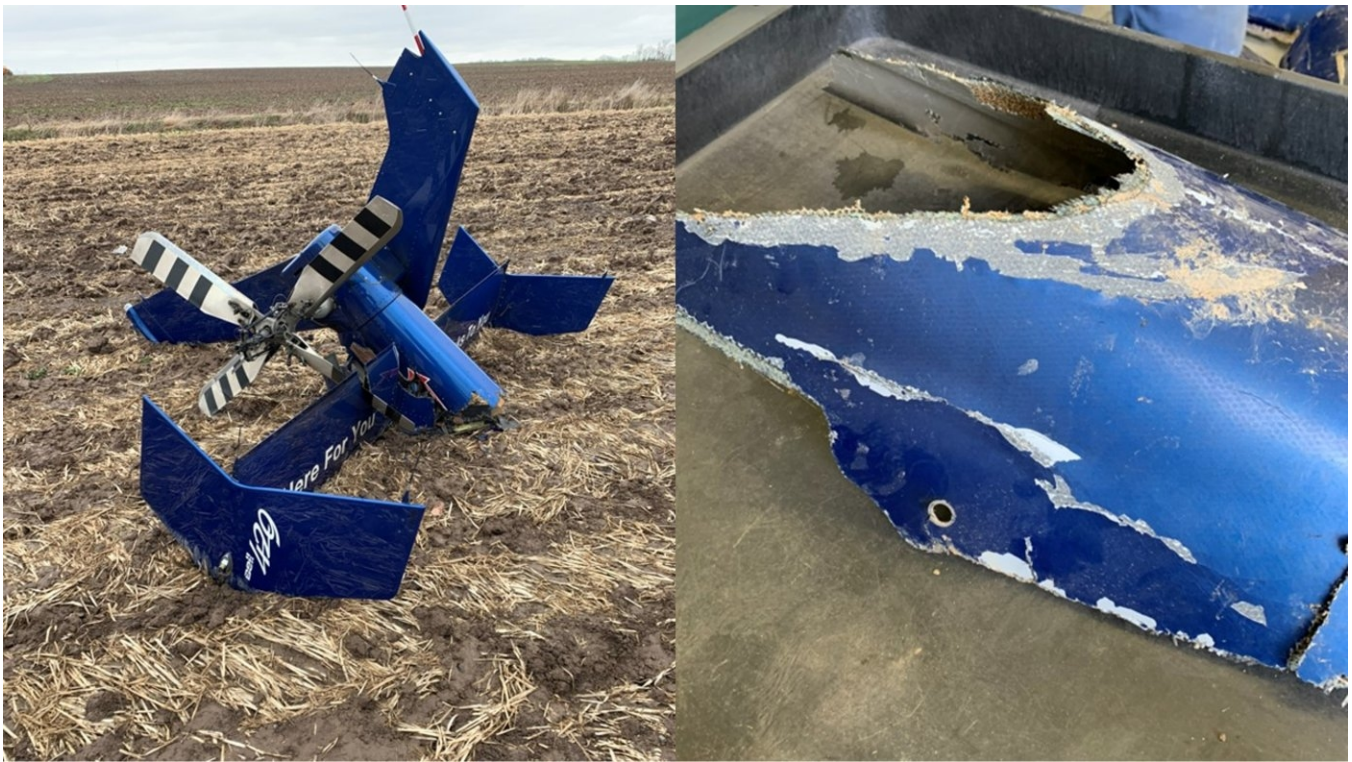
msl. The helicopter came to rest on its left side and a small post-crash fire developed but was quickly extinguished by first responders. The wreckage path was about 1,900 ft long and oriented in a direction of 250°. The tail boom, containing the tail rotor, drive shaft, vertical fin and horizontal stabilizer remained largely intact and was discovered about 390 ft from the main wreckage, on a heading of about 075°. A section of the tail boom and carbon fiber tail rotor shaft was discovered 1,620 ft and 072° from the main wreckage; it exhibited an angled fracture line consistent with main rotor blade contact. (Figure 1)

Figure 1 Figure 1 Tail rotor and main rotor blade slice in tail boom.
